Manhole Inspection Summary

Manhole # S21GG2018MH

Insp Date: **11/15/06 9:09 AM**

Location Address: **1119 BELLEMORE RD** Cross Street: **HARRINGTON RD**

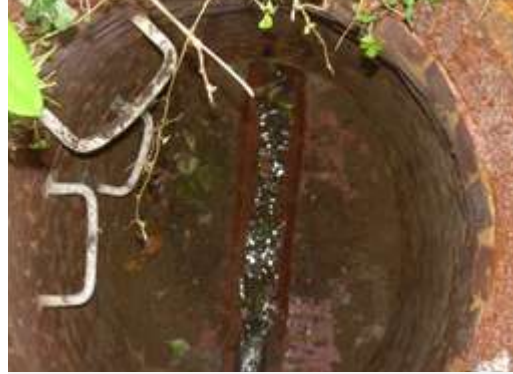
Top View

Adjustment deterioration and infiltration.
Bench debris. Channel debris.

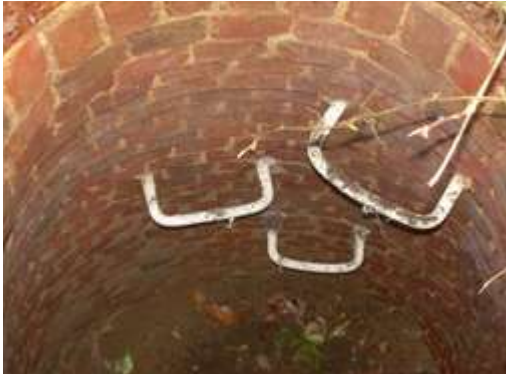
Defect

Adjustment, Corbel and Barrel infiltration.

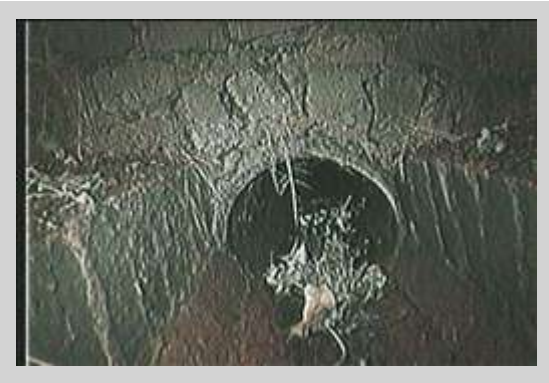
8 in. Circular Gravity Sewer Pipe Out @ 12 O'Clock

Barrel deterioration, root intrusion and infiltration. Channel deterioration.

Infiltration: **Evidence** Pipe Seal Cond: **Roots**

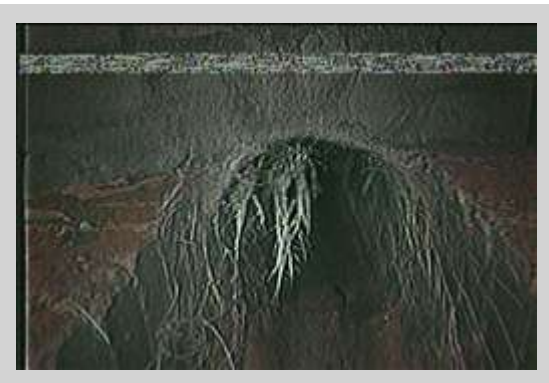
8 in. Circular Gravity Sewer Pipe In @ 6 O'Clock

Channel root intrusion.

Infiltration: **Evidence** Pipe Seal Cond: **Roots**
